OPERATIONAL IMPACTS OF ENGINE REMOVAL AND REPLACEMENT ON KEY PERFORMANCE INDICATORS IN AL-31FP ENGINES OF THE SUKHOI SU-30MKM

ABSTRACT

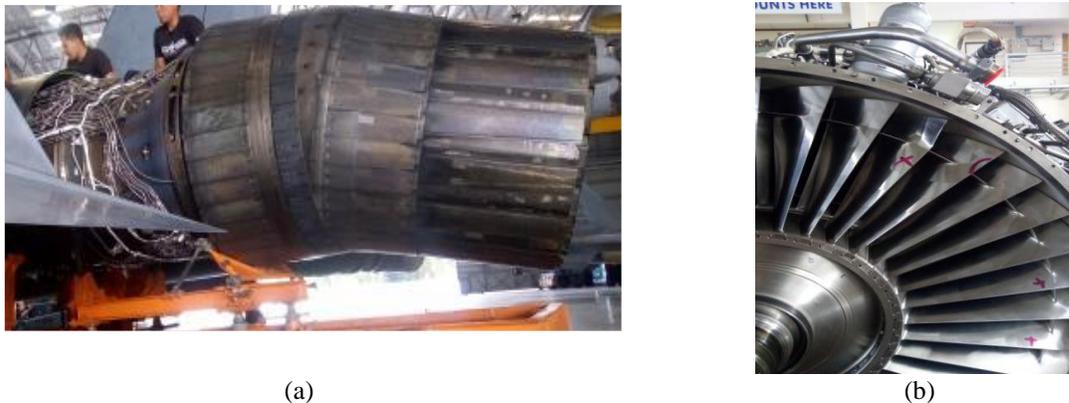
Figure 1: (a) AL-31FP engine removal and (b) Rotor blade damages for Su-30MKM fighter

Rotor blade damage can have severe consequences for engine performance. Even minor deformations, such as dents exceeding 2mm or cracks longer than 5mm, require immediate attention, as shown in Figure 1. Damage to the blade's leading edge can disrupt airflow through the engine, reducing its ability to compress air efficiently. This can lead to a decrease in engine thrust, increased fuel consumption, and, in more severe cases, a potential engine stall [2, 3]. For the Su-30MKM, which relies heavily on its engines for combat readiness, timely maintenance is crucial to avoid extended downtime and ensure the aircraft remains operational.

The process commenced with the receipt of a task card issued by the Maintenance Controller, confirming that the rotor blades of the AL-31FP engine had sustained damage exceeding the AMM's repairable thresholds. Rotor blade damage beyond 2mm depth for dents or 5mm for cracks requires complete engine replacement. The maintenance team conducted a briefing to allocate tasks, review safety protocols, and ensure that all necessary tools and resources were prepared. Emphasis was placed on ensuring operational continuity and minimizing aircraft downtime during the replacement.

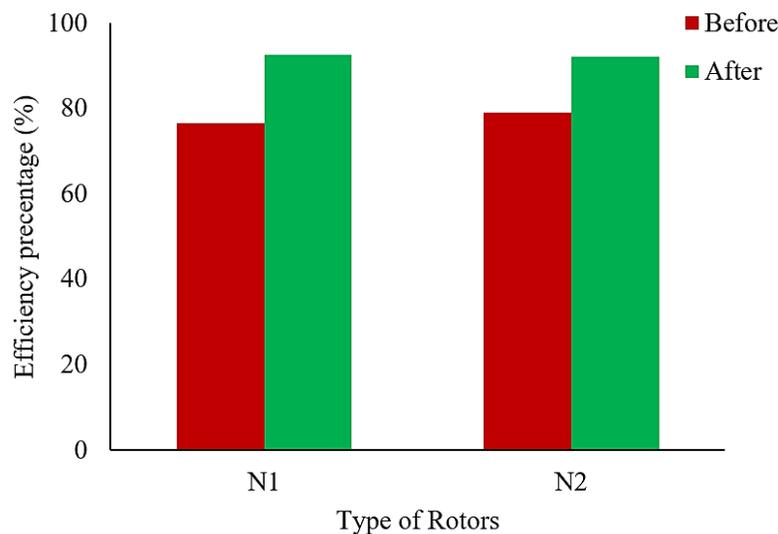
Figure 2: N_1 and N_2 monitoring of the AL-31FP engine in Sukhoi Su-30MKM

As shown in Figure 2, the N_1 rotor blade efficiency before engine replacement was 76.4%, below the operational threshold of 82% to 98.8%. This indicated a reduction in low-pressure air compression, leading to reduced thrust generation and compromised flight performance. After engine replacement, N_1 efficiency improved to 92.5%, well within the acceptable operational range. Similarly, N_2 rotor blade efficiency, which was initially 79%, below the minimum acceptable limit of 84%, improved to 92% post-replacement. These improvements highlight the restoration of both the low- and high-pressure compressors, crucial for maintaining optimal engine performance.

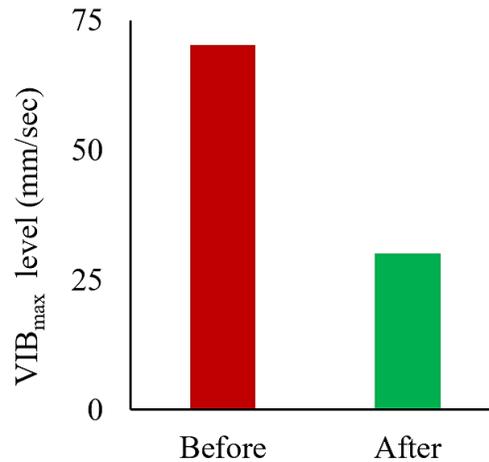
Figure 3: VIB_{max} monitoring of the AL-31FP engine in Sukhoi Su-30MKM

Meanwhile, excessive vibration, such as the 70.21 mm/sec recorded before the engine replacement, poses a significant risk of component wear and eventual failure. VIB_{max}, which measures the maximum vibration level within the engine, is a key indicator of mechanical stress and alignment. Excessive vibration can lead to mechanical stress and eventual failure of engine components. After the engine replacement, as shown in Figure 3, VIB_{max} was reduced to 30.12 mm/sec, well within the safe operational range, ensuring proper alignment of engine components and restoring the engine's mechanical integrity and long-term reliability.
