# UNDERWATER HULL MAINTENANCE OF SHIP UNDERGOING PAINTING PROCESS AT BOUSTEAD NAVAL SHIPYARD

## ABSTRACT

This study is focused on underwater hull maintenance involving the painting aspects of a class A shipyard, namely Boustead Naval Shipyard. The research is about best practices in underwater hull surface preparation and subsequent painting process for a ship undergoing maintenance at the shipyard and whether best practices are adopted in accordance to international standards or otherwise. The methodological approach conducted for this research is through journal, reference analysis, statistics, observation as well as interviews.

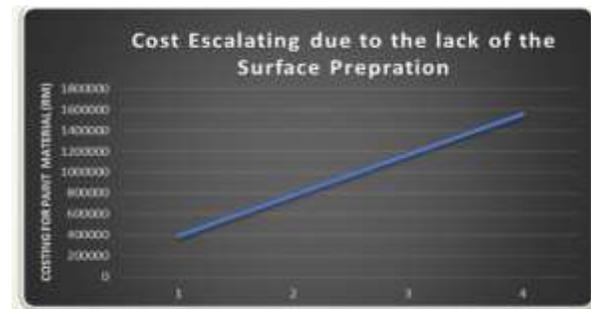
Figure 1. Cost Escalation Due to Lack of Surface Preparation

Figure 1 indicates the cost escalation due to the lack of surface preparation. The graph shows the total cost for paint is RM388954 and it may increase due to lack of a proper surface preparation and subsequent reworks. It is strongly recommended that Boustead Naval Shipyard Sdn Bhd considers the use of the salt test for every ship undergoing maintenance for repainting process at their shipyard. This is to ensure that the painted underwater surface remains sustainable throughout the ship's operational duration and needing another up-slip only when next routine is due based on maintenance cycle, not having to be up-slipped due to some unnecessary and costly emergency reasons such as underwater hull failures due to paint peeling or damage by barnacles due to poor surface preparation and anti-fouling paint application.
